To: All RedMax Distributors and Dealers
Subject: GZ3500T Carburetor

PRODUCT MODEL	SERIAL NUMBER
GZ3500T	Serial Number 8XXXXXXXX

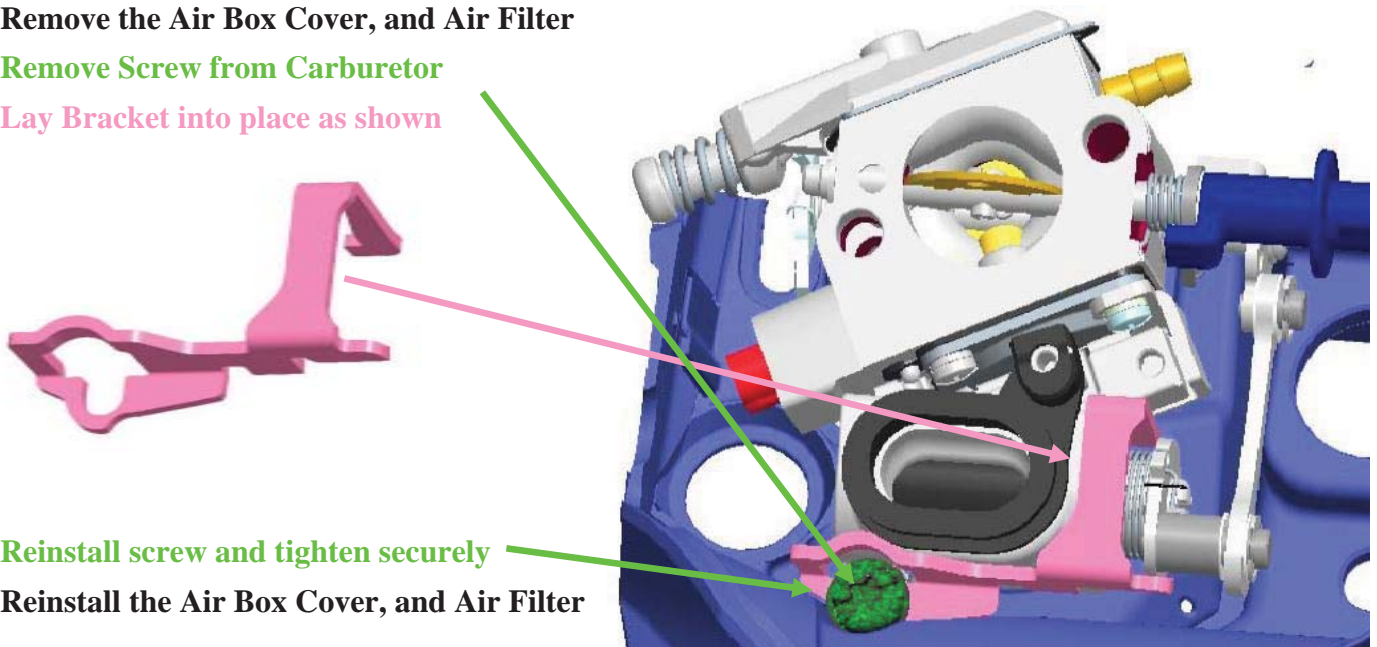
Problem:The Air Valve could become misaligned at idle preventing advancement of the throttle.

1. Remove the Air Box Cover, and Air Filter
2. Remove Screw from Carburetor
3. Lay Bracket into place as shown

Solution: Install alignment bracket on the air valve. This bracket will keep the Air Valve linkage aligned with the Throttle Valve linkage when the Throttle lever is depressed.

4. Reinstall screw and tighten securely
5. Reinstall the Air Box Cover, and Air Filter
