**Sujet :** joint de la valve à essence des moteurs hors-bord **PARSUN 5hp**

**Object :** **PARSUN 5 hp** outboard motors gas valve seal

**PRODUITS : MOTEURS HORS-BORD PARSUN 5hp**

**PRODUCTS : PARSUN 5hp OUTBOARD MOTORS**

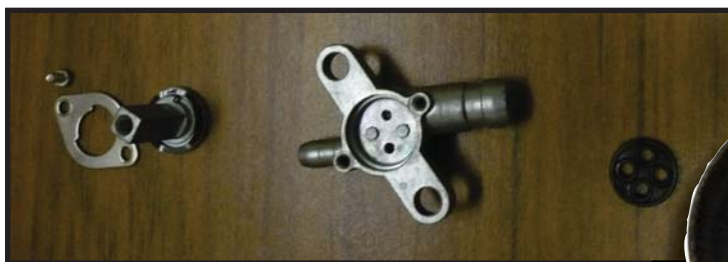
Nous avons remarqué que le joint de la valve à essence se déformait et réduisait le passage de l'essence à travers celui-ci. Nous avons mentionné ce problème à la compagnie Parsun. Depuis mars 2009, le matériel de ce joint a été changé et il est maintenant résistant au mélange éthanol et essence E15 (15% d'éthanol et 85% d'essence).

We noticed that the seal of the gas valve is deformed and reduced gasoline flow. We mentioned this problem to Parsun Company. Since March 2009, the material of this seal has been changed and is now resistant to ethanol and gasoline blend E15 (15% ethanol and 85% gasoline).

trous déformés  
deformed hole

Si l'un de vos clients remarque que son moteur Parsun 5 hp (modèle antérieur à 2009) s'arrête après quelques minutes de fonctionnement, vérifiez cette valve. Il est possible que ce soit le problème p/n PAPF4-05000100.

If one of your customers notice that his Parsun 5 hp motor (model prior to 2009) stops working after a few minutes, check this valve. It could be the p/n PAPF4-05000100 problem.
